West Midlands Surveys LTD
Chartered Surveyors

LEVEL THREE

Your survey report

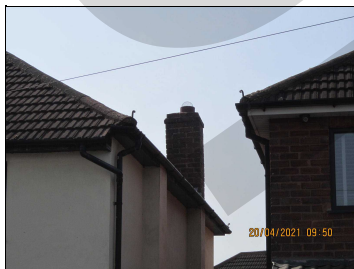
D1 Chimney stacks

There are two brick built chimney stacks. The front chimney stack has been reduced below eaves level, is capped and now redundant.

The rear chimney stack shows general weathering but condition was consistent with age. The chimney stack is fitted with an open pot with a wired grille terminal. Open chimney pots should be fitted with a terminal fitting that will prevent rainwater and nesting birds entering the chimney flue which may cause problems with dampness to inside walls or to the flue becoming obstructed. Condition rating 2.

The front chimney stack has been reduced below eaves level, is capped and now redundant. There is no evidence of ventilation to the sealed flue. Redundant flues should be ventilated to guard against condensation occurring within the sealed flue. Condition rating 2.

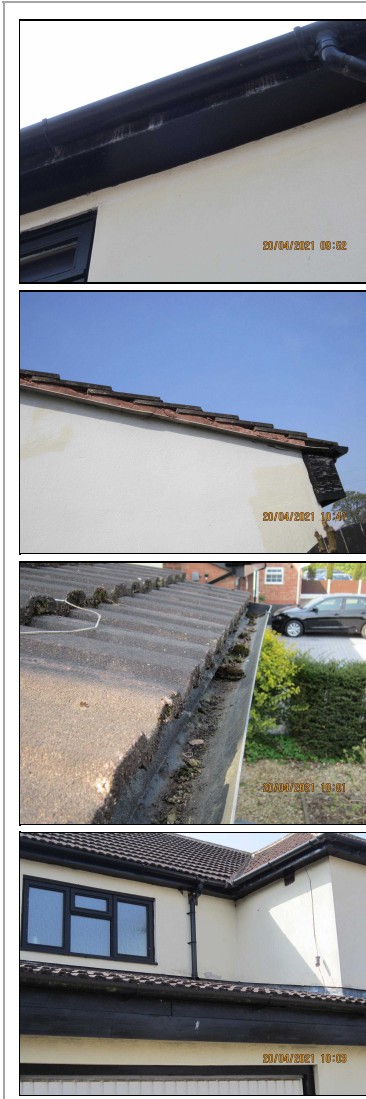
D2 Roof coverings

The main sloping roof is covered with tiles over a secondary waterproof barrier. There is evidence of general weathering along with past re-pointing to ridge, hip and valley tiles however the condition was considered to be consistent with age. Condition rating 1.

There is a single pitched tiled canopy to the front single storey wing. The tiles show some general weathering but were considered to be in serviceable order. Verge tiles to the left side elevation require some patch re-pointing. Under cloaking boards may be formed from asbestos containing materials. Specialist Contractors should be consulted before undertaking work to this material. There is a shallow gradient to the tiled roof covering. We cannot confirm that these tiles are appropriate for this angle of pitch, however no sign of water penetration was noted to the ceilings below at the time of our inspection. Condition rating 2.

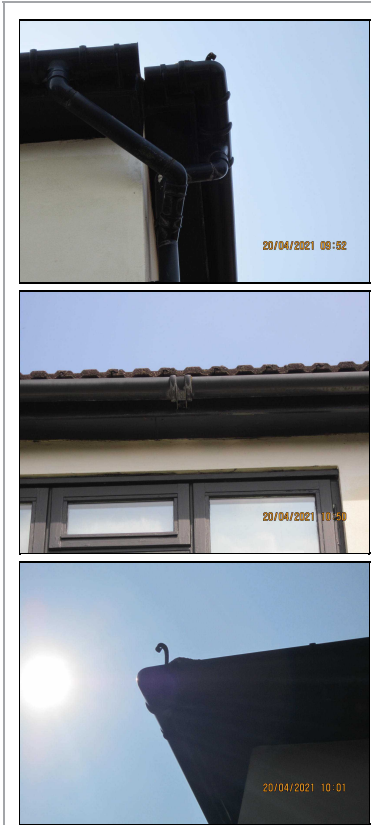
D3 Rainwater pipes and gutters

Rainwater goods are of plastic construction. Evidence of leaks and congestion/overflow were noted to gutters/downpipes. Rainwater goods show some general weathering and should be subject to routine overhaul to include removing debris, re-sealing joints and re-alignment as necessary. Condition rating 2.

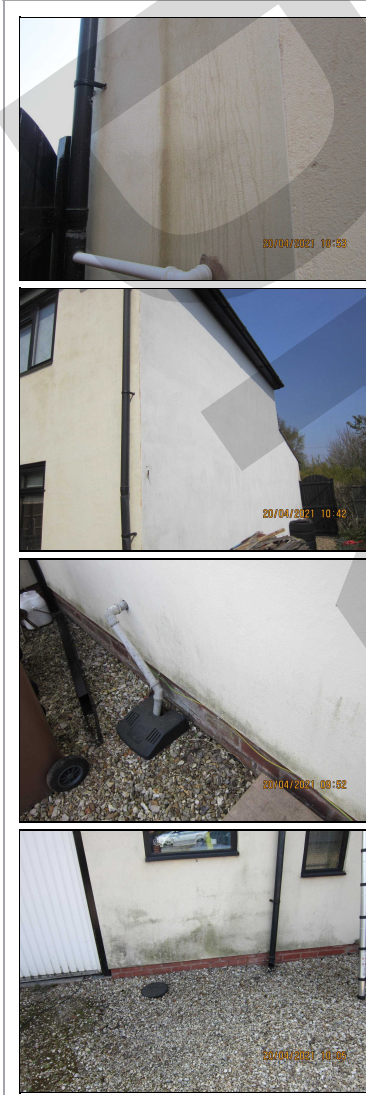
D4 Main walls

The external walls to the original building and later extensions are made of brick with an air gap between the inside and outside faces (called a cavity) with a rendered finish. The render shows signs of general weathering with more severe weathering to the front elevation. There is some evidence of minor localised damage to the render, particularly at ground floor level above the stop beading as well as some general deterioration below window frames. A number of hairline cracks were noted along with large cracks above the garage door. The hairline cracks were considered to be longstanding and non-progressive in nature. You should make provision for localised repair to damaged render and routine redecoration. Condition rating 2.

The outside wall has a barrier against dampness rising from the ground (called a damp proof course or DPC) consisting of slate to the original building and PVC to the later extension. There is evidence of dampness internally indicating that the damp proof course is beginning to deteriorate and requires maintenance. Comments made elsewhere in this report (Section F9) should be noted.

Sub-floor ventilation is provided by a series of air bricks however these are not considered to be adequate in number and are obstructed in places. Comments made later in this report relating to sub-floor ventilation should be noted (see Section F4).

More severe staining of render at ground floor level is due to defective rainwater goods/roof covering and comments made elsewhere in this report recommending maintenance should be noted (see Sections E3 & E2).

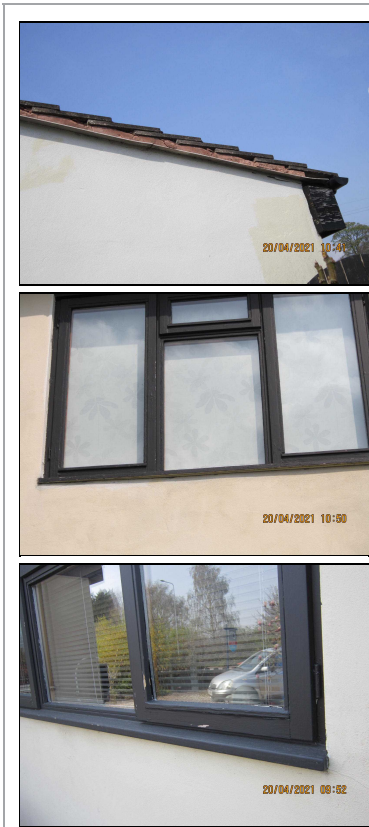
D5 Windows

Windows are timber joinery with sealed unit double-glazing. Decorated finishes are beginning to weather and the original standard of decoration is considered to be untidy and to a basic standard of finish. There is some evidence of deterioration to timber joinery below painted finishes particularly to the kitchen window frame to the front elevation and first floor window frames to the rear elevation. Window frames require routine redecoration and you should make provision for repair to deteriorating timber joinery. Condition rating 2.

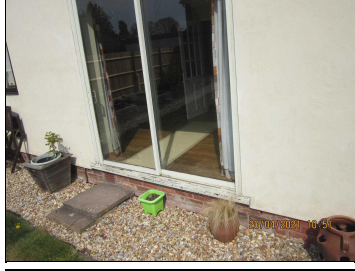
A photograph of a rear patio window with a white frame and double-glazed units. The window is set in a light-colored wall. A timestamp '20/04/2021 10:51' is in the bottom right corner.	<p>The outer doors to the front and right side elevations are made of timber. Some general weathering was noted to decorative finishes. Doors were found to be in generally serviceable order although would benefit from routine redecoration. Condition rating 2.</p> <p>The French window to the rear elevation is formed from hardwood timber, shows signs of general weathering and would benefit from routine redecoration but was considered to be in serviceable order. Condition rating 2.</p>

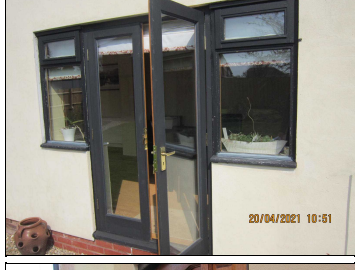
A photograph of a rear patio window with a white frame and double-glazed units. The window is set in a light-colored wall. A timestamp '20/04/2021 10:51' is in the bottom right corner.	<p>The rear patio window is constructed from an aluminium casement with double-glazed units set in a timber frame. There is evidence of general deterioration to the timber frame which requires routine maintenance and redecoration. Condition rating 2.</p>

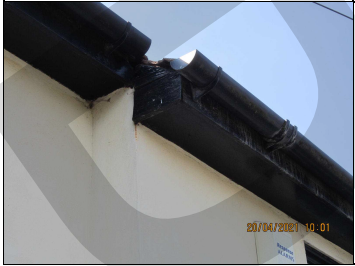
D8 Other joinery and finishes

<p style="text-align: right;">2</p> <p>The soffits, fascia and barge boards are of timber construction and show general weathering and deterioration to timber. Redecoration is required and close inspection may reveal further deterioration and rot. You should budget for additional repair to these areas when redecoration is undertaken. Condition rating 2.</p> <p>Rainwater stains were noted to the fascia boards, particularly to the front elevation this suggests a problem with leaks from rainwater goods and/or defective eaves felt (comments made elsewhere relating to overhaul of rainwater goods and the condition of eaves felt should be noted – see Sections E2, E3 & F1).</p> <p>Timber soffit and fascia boards across the front wing projection show some general weathering and localised deterioration. Timber joinery would benefit from routine redecoration and making good of deteriorating timber. Condition rating 2.</p>

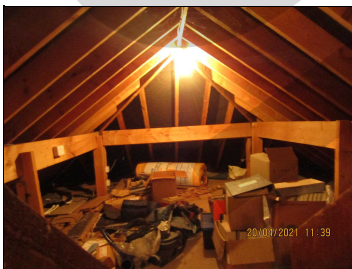
E1 Roof structure

The roof void was found to be partially boarded and used for storage which restricted movement around the roof void. Our inspection is therefore restricted. Floorboards fitted onto ceiling joists and are suitable for light storage only. We recommend that the contents of the roof void be removed.

The roof structure is built of timber with felt below tiles. No obvious sign of defect was noted to the roof structure. Condition rating 1.

The lower layer of roofing felt (e.g., at eaves level) is prone to deterioration. This area is hidden from view and comment cannot be made on its condition. There is external evidence to suggest that some deterioration should be anticipated. Condition rating 2.

The roof space does not have enough ventilation. A lack of ventilation in the roof space can cause mould growth and wood rot and additional ventilation should be provided soon. Condition rating 2.

The roof space has some insulation but is below current recommended levels and would benefit from upgrading.

It was not possible to gain access to the roof void above the front single storey projection and we are unable to comment upon its condition. Not inspected. However from our external inspection we would advise that there is no evidence of ventilation to this roof void and this would be recommended, nor can we confirm the existence of any insulation as would be recommended under current Building Regulations. There is evidence of deterioration to the roofing felt. Condition rating 2.

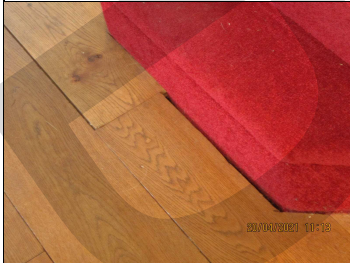
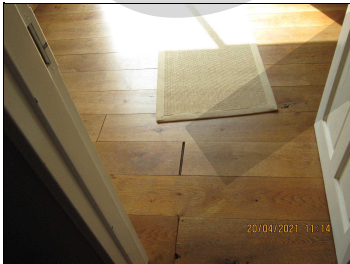
E4 Floors

There is a suspended timber floor to the reception hall and rear reception room (original building). The timber floors are inadequately ventilated. To make sure that the timber floors do not rot it is important to provide ventilation to the under floor space. Although I did not find a problem with this floor there is not enough ventilation. To prevent future problems you should provide additional ventilation soon. You may wish to consult a specialist PCA approved timber Surveyor to undertake a sub-floor inspection to confirm the condition of sub-floor joinery and to advise upon the need for improved ventilation. Condition rating 3.

Feature floorboarding is generally firm and even underfoot although evidence of localised saw cut damage was noted to the floorboards at the base of the staircase and a number of loose boards were noted where they have not been adequately fixed.

There is a solid ground floor to part of the reception hall, kitchen and rear reception room (extension) which felt firm and even underfoot and no particular problems were noted. Condition rating 1.

We cannot confirm that the solid floors in the older part of the property are not original. Many older solid floors do not have a barrier against dampness from the ground (called a damp-proof membrane or DPM). Solid floors of this type rely on moisture gradually passing through the floor and evaporating harmlessly in the property. In these cases, you should not use any impervious coverings (e.g. vinyl sheeting, ceramic floor tiles, foam backed carpets, etc.) because these will prevent this moisture movement creating a dampness problem in other parts of the home. If the floors are found to lack a damp membrane replacement may become necessary, this will be a costly and disruptive exercise.

There is a suspended timber floor to upper levels. This shows some distortion and unevenness a result of longstanding movement and past repair which is common in floors of this type and is not considered to be structurally significant. Condition rating 1.

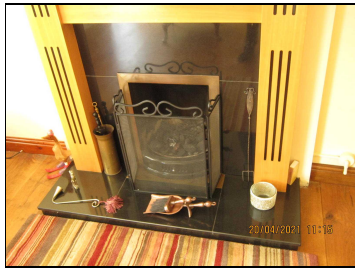
E5 Fireplaces, chimney breasts and flues

<p style="text-align: right;">2</p> <p>There are two chimney breasts within the property at ground and upper floor levels.</p> <p>The fireplace in the rear reception room is fitted with a solid fuel fire. The heating appliance should be connected to a flue pipe that allows combustion gases to escape safely and the heating appliance to work efficiently. It is not possible to inspect the chimney flue and we are unable to comment upon its condition, nor can we confirm that the class of flue is appropriate to the appliance. The flue and the associated heating appliance should be serviced annually and prior to first use. Not inspected.</p>

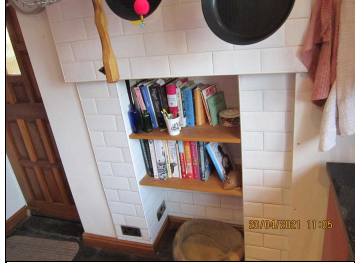
<p>The fireplace in the kitchen has been sealed. When a fireplace has been taken out of an external chimney breast and the opening blocked up, the following work should be done; the top of the flue at chimney level should be fitted with a terminal fitting that keeps out the rain but allows ventilation of residual moisture in the flue. The sealed flue should be fitted with ventilating air bricks to the outside air towards the bottom of the flue, to help reduce the risk of condensation in the sealed flue. Condition rating 2.</p>

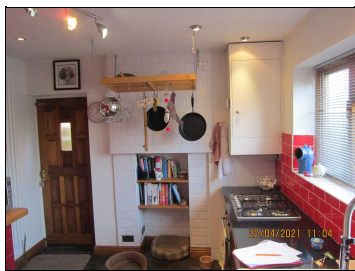
E6 Built-in fittings (built-in kitchen and other fittings, not including appliances)

<p style="text-align: right;">1</p> <p>Kitchen fittings were found to be modern and although showing signs of some general wear and tear, were considered to be in serviceable order. Condition rating 1.</p>
---	---

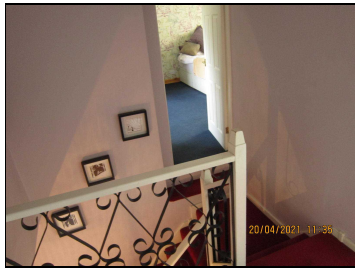
E7 Woodwork (for example, staircase joinery)

<p style="text-align: right;">2</p> <p>Internal decoration has been subject to some wear and tear but was felt to be in fair order for its type and age. Condition rating 1.</p>

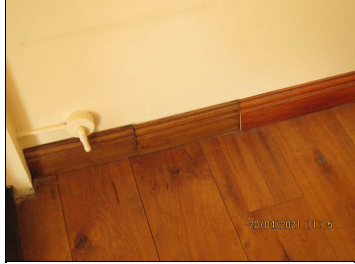
<p>Internal joinery has been subject to some wear and tear localised damage/repair. Evidence of localised repair was noted to damaged skirting boards with some loose fitting sections around the ground floor WC and reception hall. Joinery requires routine maintenance. Condition rating 2.</p>

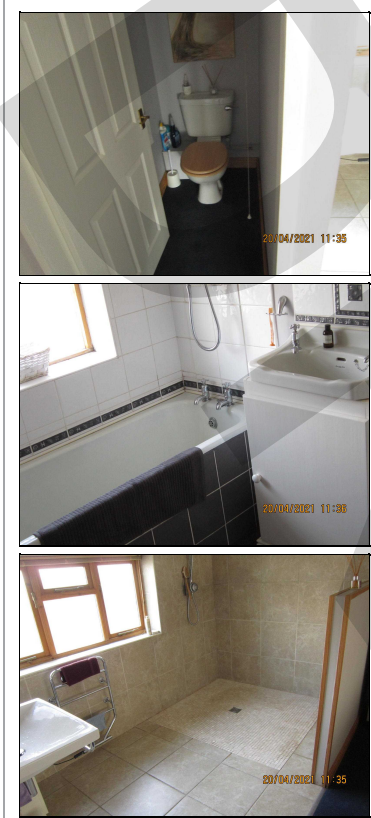
E8 Bathroom fittings

Ground floor WC fittings are of a modern design show wear and tear but were found to be in functional order. Condition rating 1.

En-suite fittings to the master bedroom are of a modern design show wear and tear but were found to be in functional order. Condition rating 1.

Guest bathroom fittings are of mixed age, show wear and tear but were in functional order. The cold water bath tap has seized and could not be operated. The tap requires easing. The shower enclosure above the bath overlaps the adjacent window frame and the cubicle is not fully watertight. Evidence of damp staining was noted to the outer window frame which requires redecoration. There is no extractor unit to the bathroom and we recommend that one is provided to help control levels of moisture and condensation. Condition rating 2.

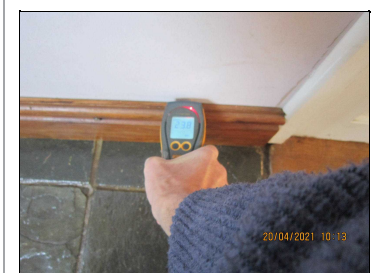
E9 Other

Some patches of localised dampness were noted to lower walls. Whilst the problem is not extensive it is an indication that the damp course is beginning to deteriorate and future maintenance will be required. A full damp survey should be undertaken by a PCA approved Surveyor to confirm the need for remedial work now. Condition rating 3.

Damp meter checks were made against internal walls and some high damp meter readings were noted. A PCA approved specialist damp Surveyor should be asked to undertake a full damp course inspection with recommendations acted upon.

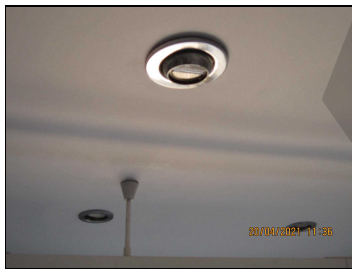
F1 Electricity

The property connects to a mains electric supply with the meter located in an external box and consumer unit being located in the garage. I saw evidence that the electrical system has been subject to limited updating from original, however we have not seen any certification for this work. Some adaptations appear to have been made that will have required certification by an Electrician (e.g., replacement consumer unit, spotlighting and external wiring). The system appears to be past its periodic inspection date. The Institute of Electronics and Technology (IET) recommends that electrical systems are inspected and tested every ten years and upon every change of occupancy. You should ask an appropriately qualified person to inspect the electrical system now. Condition rating 3.

We recommend the installation of hard wired smoke alarms. Condition rating 2.

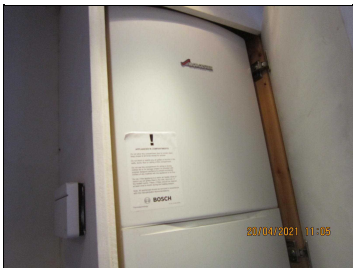
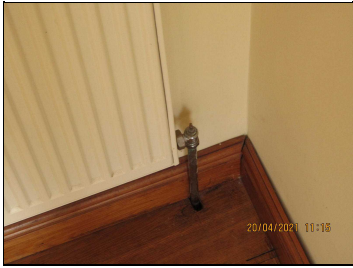
F4 Heating

<p style="text-align: right;">3</p> <p>The property is heated by a fixed heating system consisting of a Worcester gas boiler heating water filled radiators. We have seen evidence of recent servicing with a Gas Safe service certificate provided by Gasco, Reg. No. 35742 dated 9th March 2021 to confirm recent servicing. We recommend that servicing of the boiler by a Gas Safe Engineer continues on an annual basis. Condition rating 1.</p> <p>A number of loose/missing valves caps were also noted which require routine maintenance. Condition rating 2.</p> <p>It is not clear that the room containing the solid fuel fire is adequately ventilated to the outside air, and this may be a safety hazard. Open flue heating appliances discharge combustion gases into a vertical pipe or chimney. To work efficiently and safely, there should be ventilation openings to the outside air to the room and a suitable fitting on the top of the flue (e.g., called a terminal fitting). There will be a safety hazard for the occupants if these are missing or not effective. I could not find any ventilation to the room. You should ask an appropriately qualified person to check this now and you should not use this appliance until this has been done. Condition rating 3.</p>

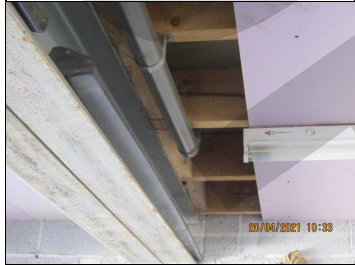
G1 Garage

<p style="text-align: right;">2</p> <p>There is a single part integral garage with brick walls, solid concrete floor, boarded ceiling and metal up and over door. Evidence of localised deterioration was noted to the outer door frame and joinery which requires routine maintenance and redecoration. The internal window frame does not comply with current Fire Regulations and should be removed. Ceiling boarding is unfinished and there is no boxing around the RSJ as would be required under current Fire Regulations. There is no evidence of insulation between the garage ceiling and room above which is recommended. The inner garage door should be fitted with a closing mechanism to conform with current Building Regulation requirements. The garage requires maintenance to conform to current Building Regulation requirements. Condition rating 2.</p>
